# Flight Motor Set 360L008 (STS-32R) Final Report

## Volume I - System Overview

Flight Motor Set  
360L008 (STS-32R)  
Final Report

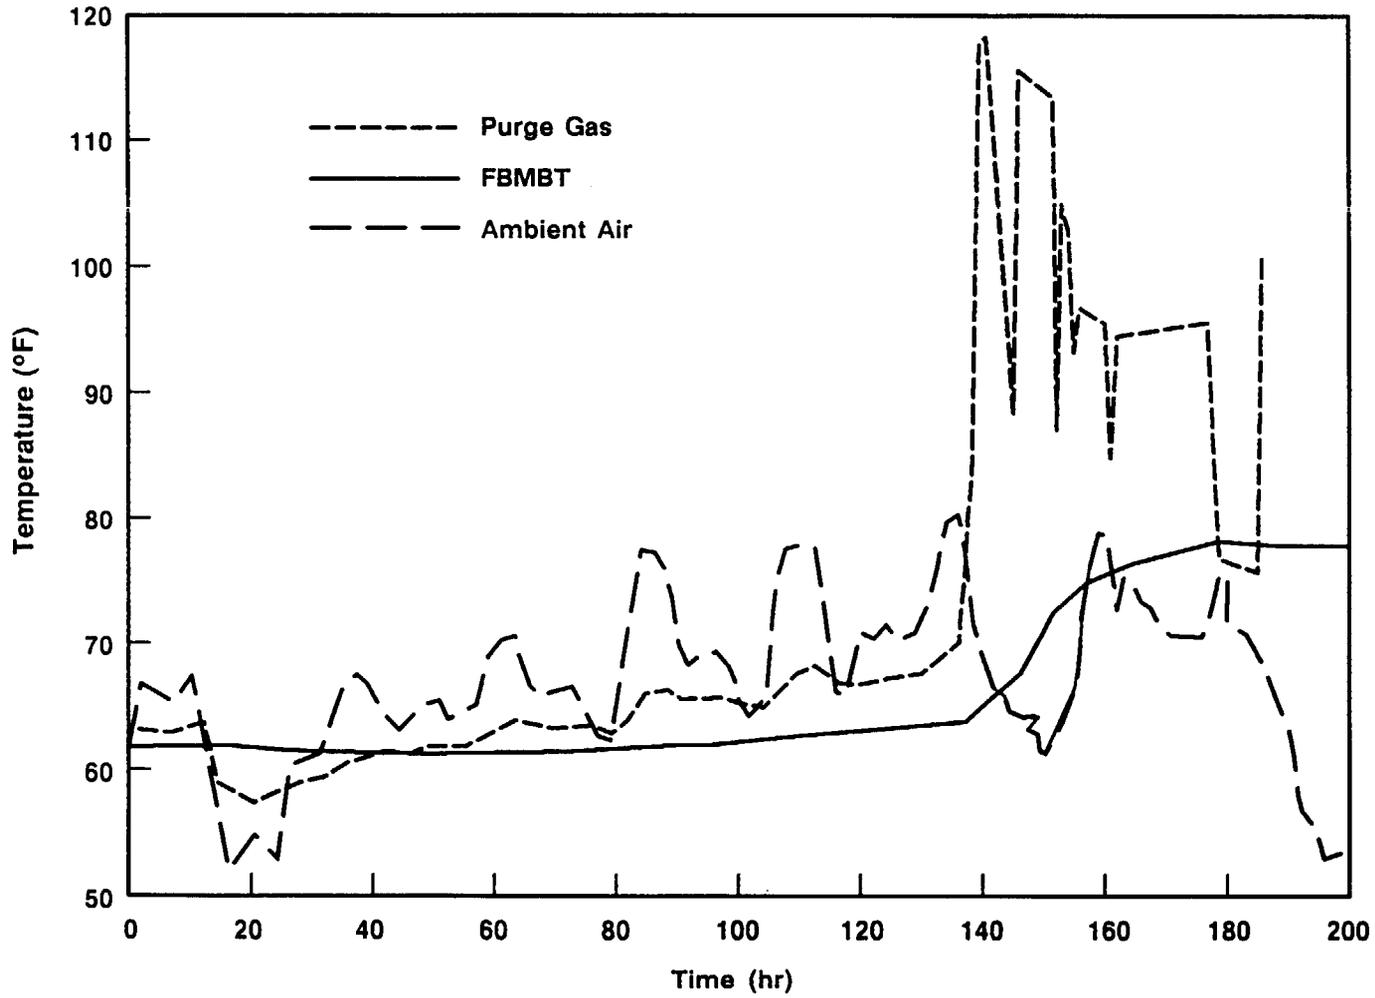
Figure 4.8-114. STS-32 RSRM FBMBT Postprediction

Figure 4.8-114 shows the postflight FBMBT prediction created from reconstructed ambient temperature and aft skirt purge data.

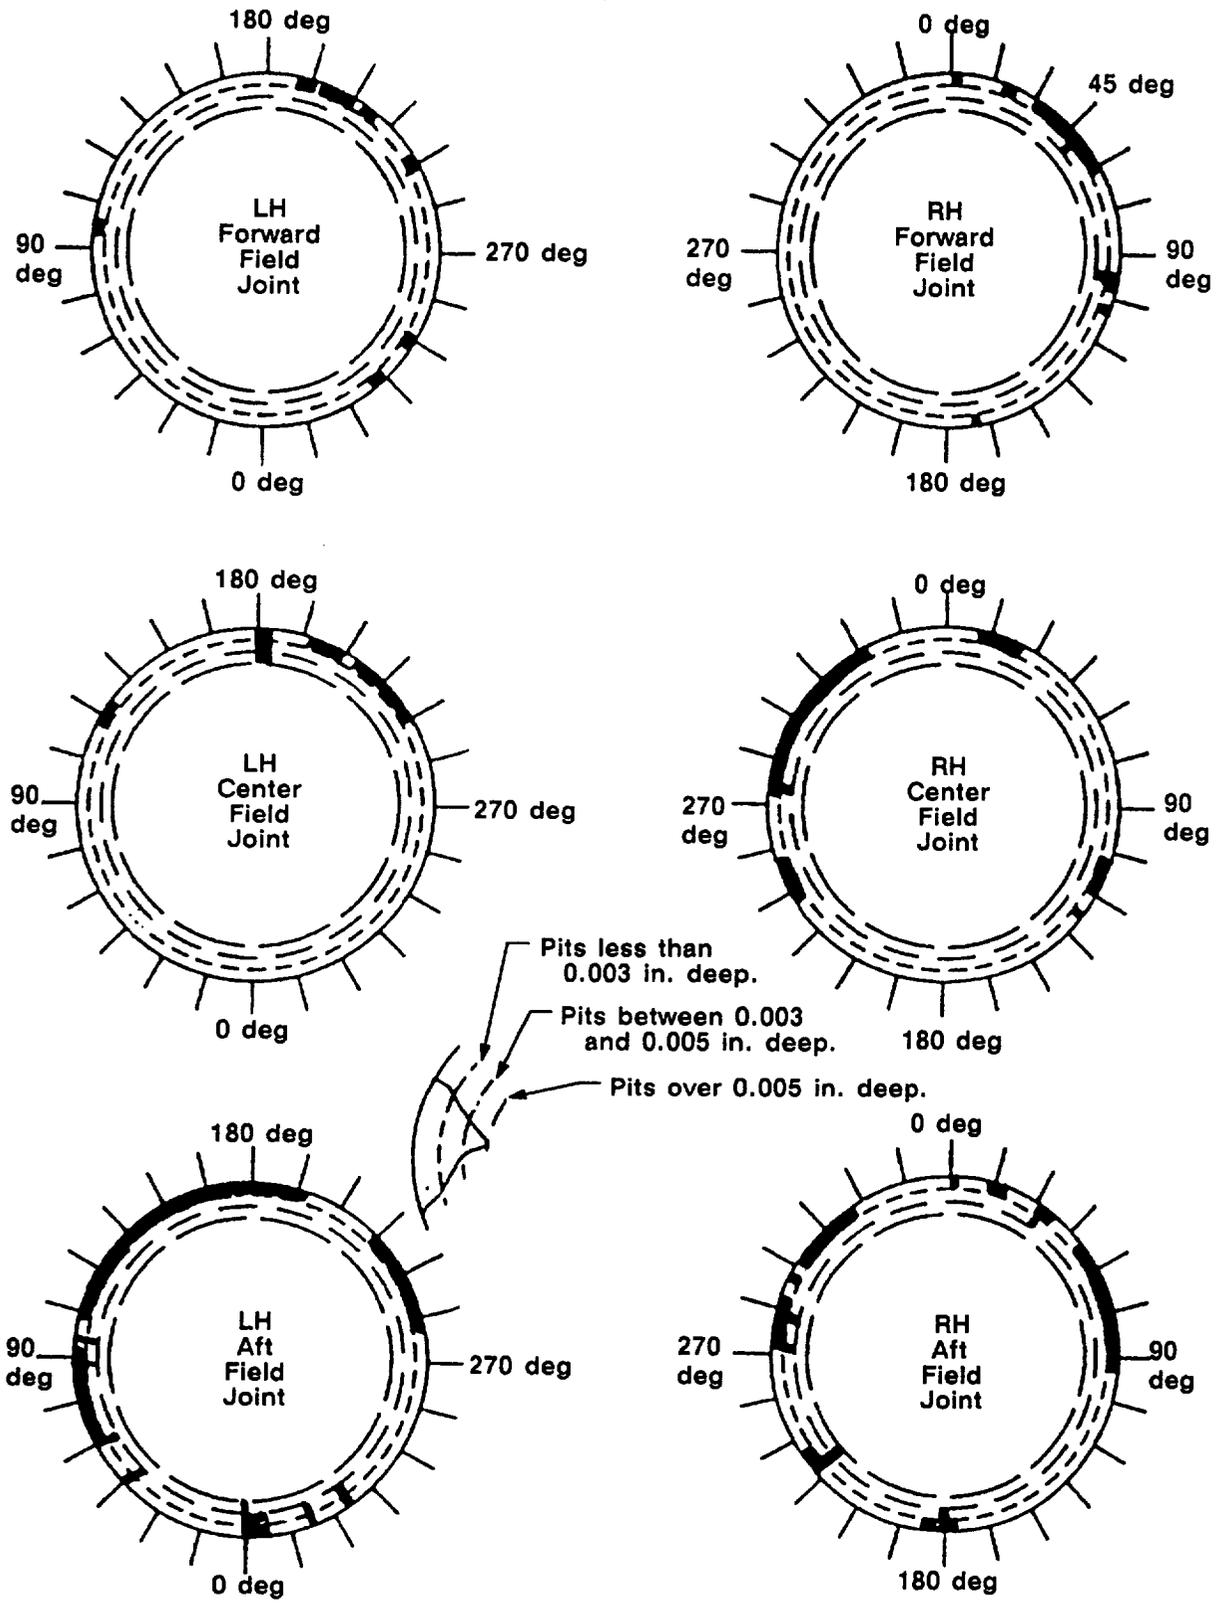
Figure 4.11-1. Field Joint Fretting 360L008 (STS-32R)

3.1.9.2 Case. The case field joint surface conditions were as expected. Field joint fretting on this flight ranged from light to heavy. All joints had some fretting. The left center and aft field joints had the worst fretting (0.007 in. deep) and the right

aft field joint had a 0.006-in.-deep fret. There were no new frets found in the old fret indications. All new fretting occurred in previously unfretted areas.
